AGARD REPORT 809

POD Assessment of NDI Procedures Using a Round Robin Test

This report was prepared at the request of the Structures and Materials Panel of AGARD

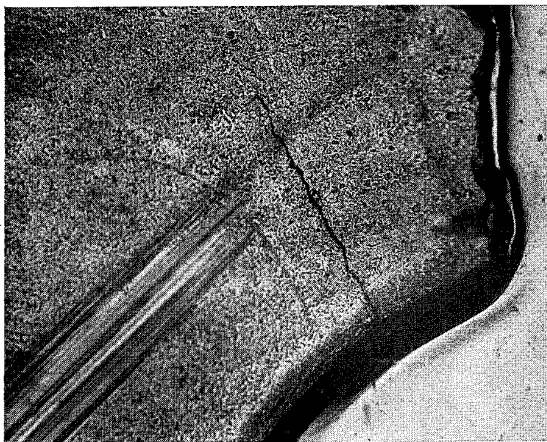
Figure 5. c) A cellulose-acetate replica of the disk surface, showing a crack
